Anti-Static & Super Hydrophilic Self -Cleaning Coat

Anti-fouling Coat Case Study

Exterior material / window glass / solar panel

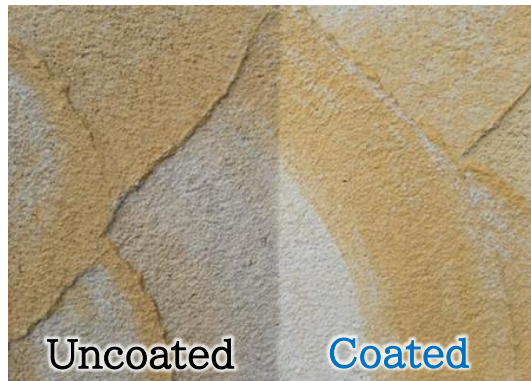
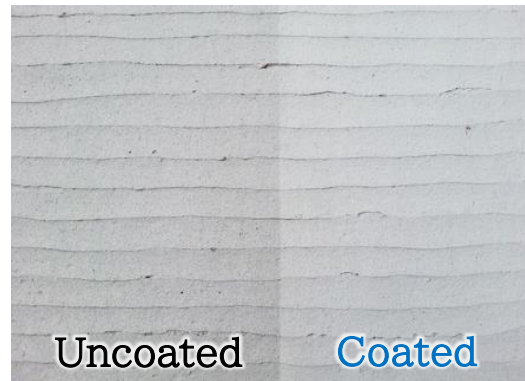
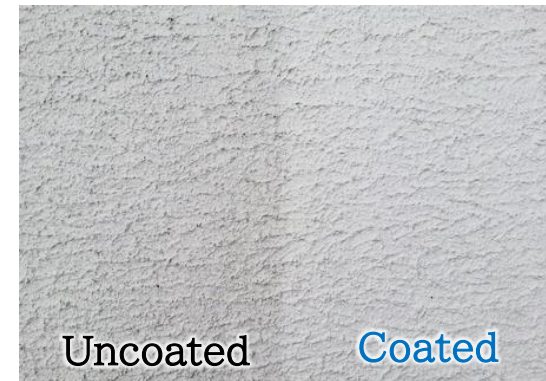
◆ 2 years after coating on the JOLYPATE

Antifouling effect in exterior materials

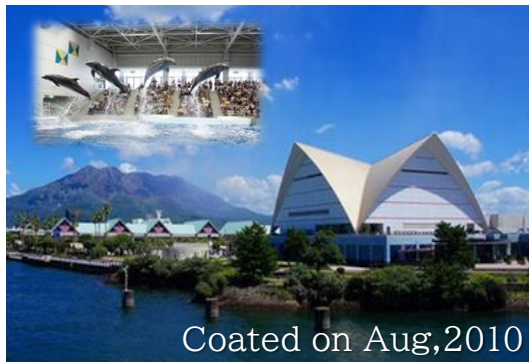
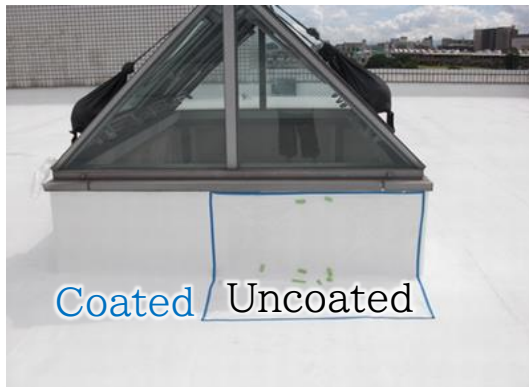
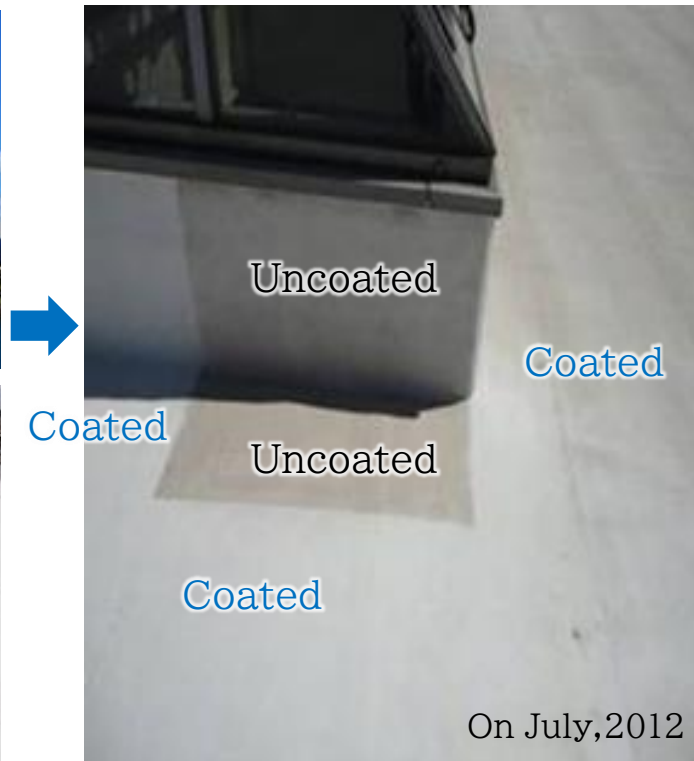
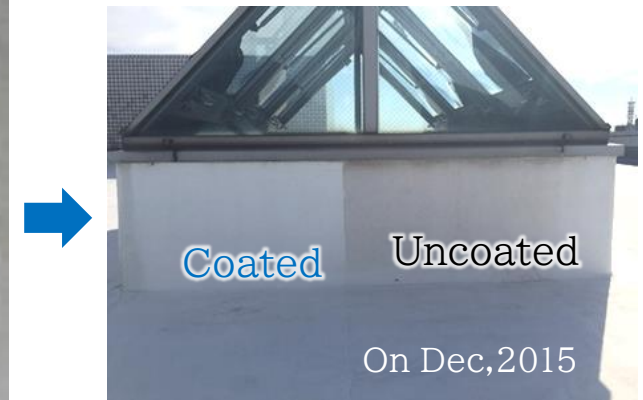
◆An antifouling coat is applied over the heat-reflective paint on the roof of the Kagoshima Aquarium in Japan, and a comparison is made with an uncoated area.

Areas where the anti-fouling coating has not been applied over the paint are gradually becoming blackened by volcanic ash and dirt each year. In contrast, the areas with the coating show significantly less dirt adhesion, effectively preventing the decrease in reflectivity of the heat-insulating paint.

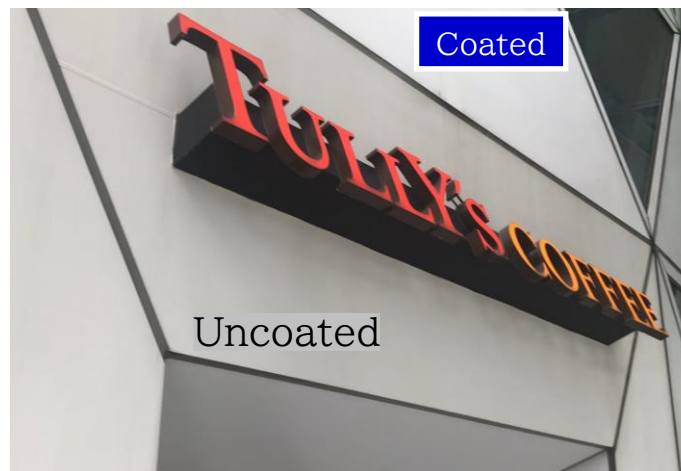
- ◆ Antifouling effect was confirmed even after 10 years after applying an antifouling coating to the exterior panels of a building in Shinjuku Station, Tokyo.

One year after the anti-fouling coating was applied, it was demonstrated that the exterior wall panels of a store that moved into the tenant space had not been treated with the anti-fouling coat, making dirt and stains noticeably visible.

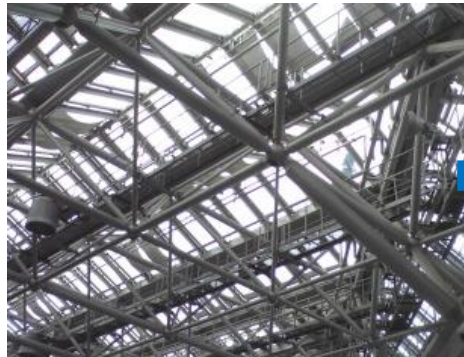
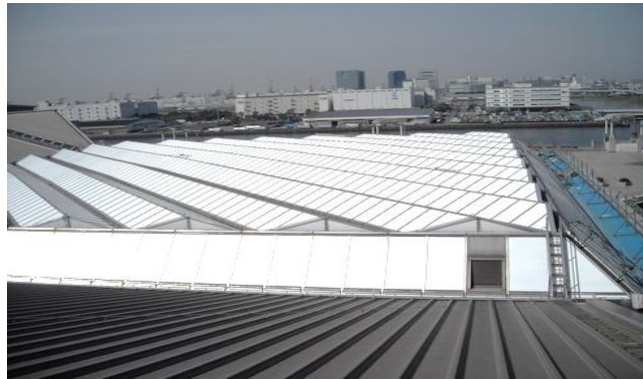
◆ To address the issue of excessive glare from the skylight glass on the roof of the West Hall at Tokyo Big Sight, heat-reflective paint was applied to the glass, followed by an anti-soiling coating. The project was carried out as a measure to reduce glare, enhance heat insulation, and maintain aesthetic appeal.

It was officially adopted, and **2,000 square meters** were applied in 2009.

Prior to the project, an exposure test was conducted comparing our heat-reflective paint with that of other companies. The areas coated with our paint and anti-fouling coating maintained their white color even after two months, while the competitor's coating showed gray discoloration on the surface due to dirt, resulting in inferior infrared reflectivity and aesthetic retention. As a result, our heat-reflective paint with an anti-fouling coating was selected, leading to an order for 2,000 square meters.

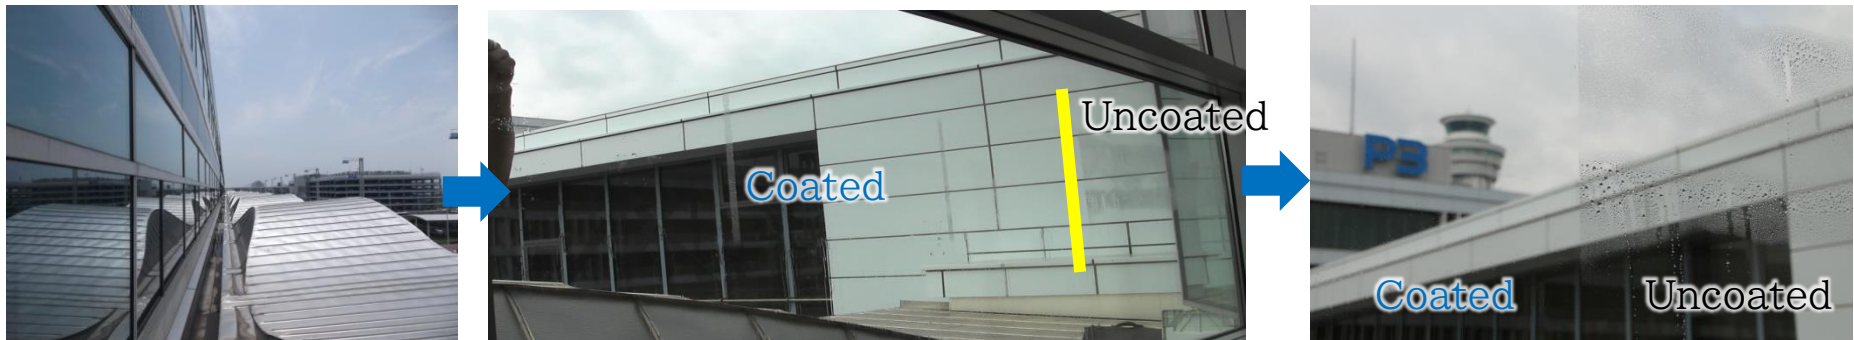
◆A certain airport in Japan: Passed the 10-month outdoor exposure test of window glass.

The current cleaning maintenance cost for exterior window glass is ¥210 million annually, with three cleanings per year (¥70 million per cleaning). The plan aims to reduce the frequency to twice a year, lowering the annual cost to ¥140 million and achieving an annual maintenance cost reduction of ¥70 million.

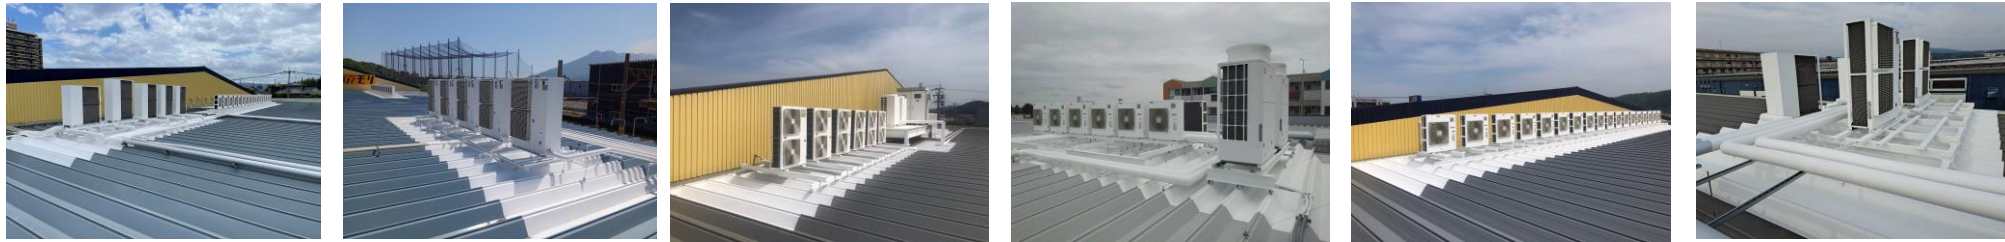
- ◆Heat-Reflective, Thermal-Insulating, Anti-Corrosion, and Anti-fouling Coating for Rooftop Outdoor Units of Drugstore Locations: **150 Stores or more × 300 sqm (More than 45000sqm) since 2020**

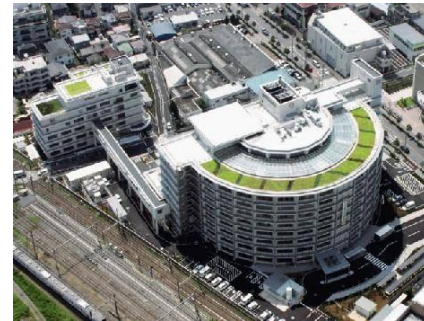
1586 sqm Applied at a Hospital in Saitama, 2022

- ◆Heat-Reflective, Thermal-Insulating, Anti-Corrosion, and Anti-Soiling Coating for Rooftop Outdoor Units and Surrounding Areas of Hospitals

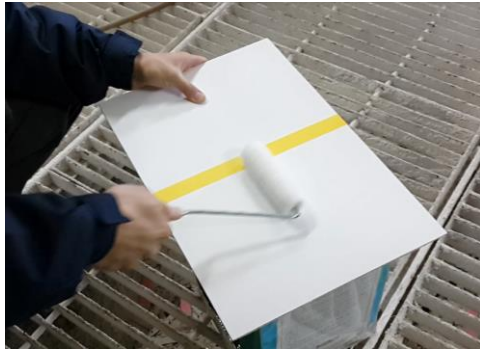
- ◆ Anti-fouling Test on White Paint Conducted at JB paint in South Korea
(the 3rd Largest Manufacturer in the Paint Industry)

Applied Super Glass Barrier to Half the Surface (November 2013)

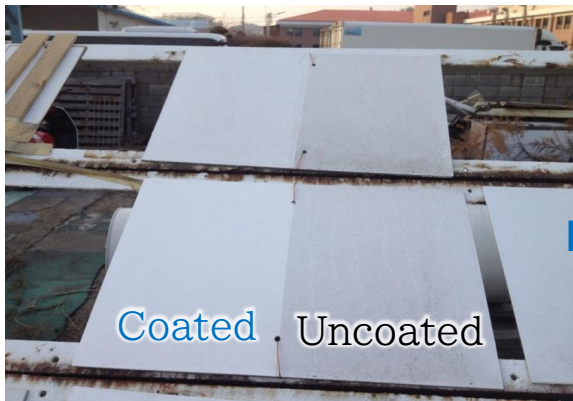
Set Up Outside

4 Months Later (March 2014)

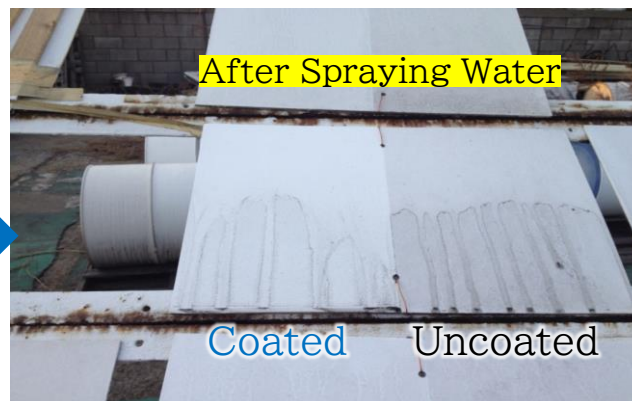
1 Year and 2 Months Later (January 2015)

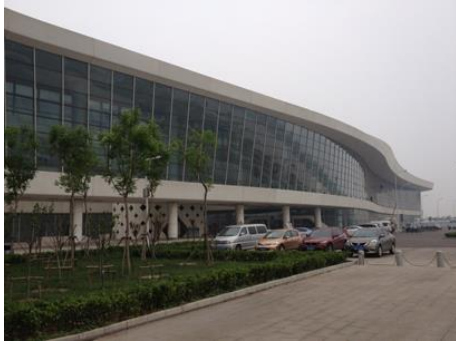
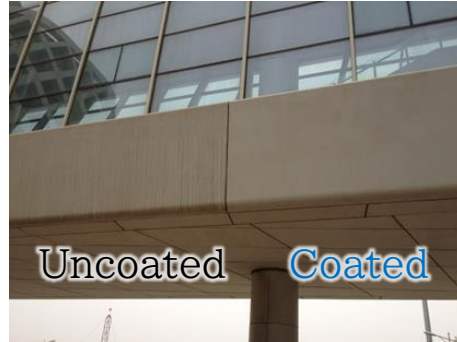
- ◆ Tianjin International Cruise Terminal for exterior concrete
Coating Area 43,000 sqm

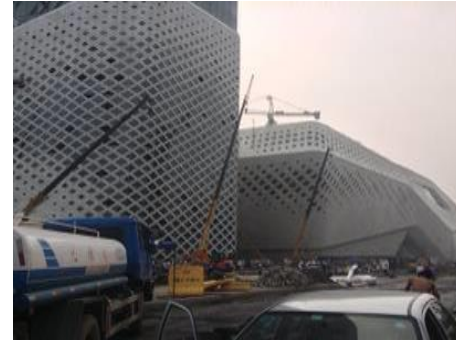
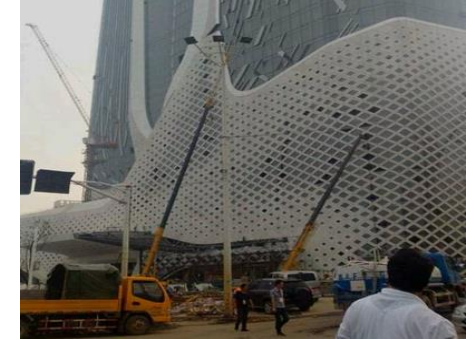
- ◆ Nanjing Youth Olympic Center / Application to Exterior
Fiberglass Concrete Coating Area 100,000sqm

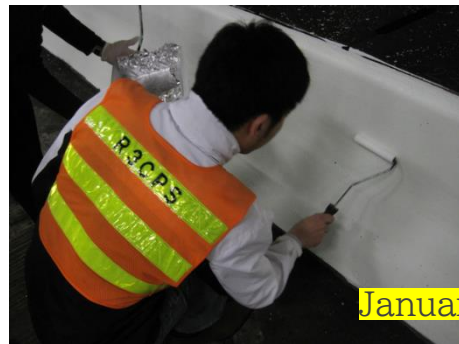
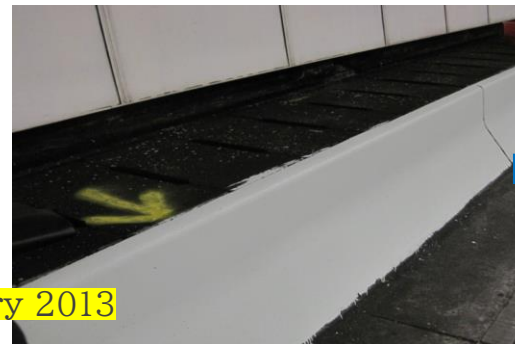
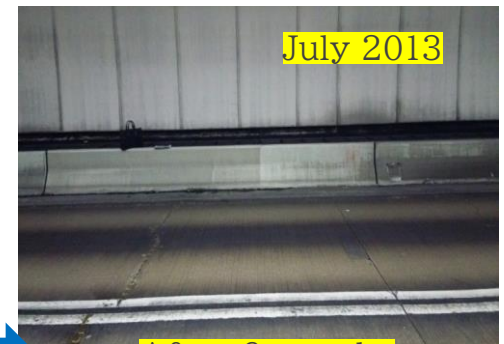
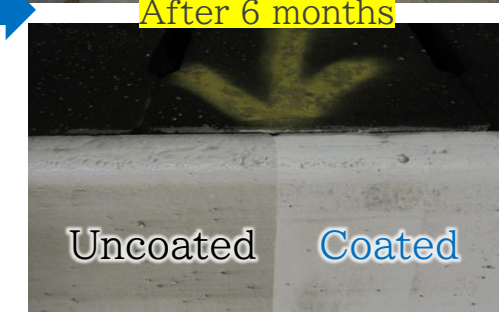
- ◆ Verification of antifouling effect on concrete in Hong Kong Tai Lam Tunnel.
At the time of verification after 6 months.

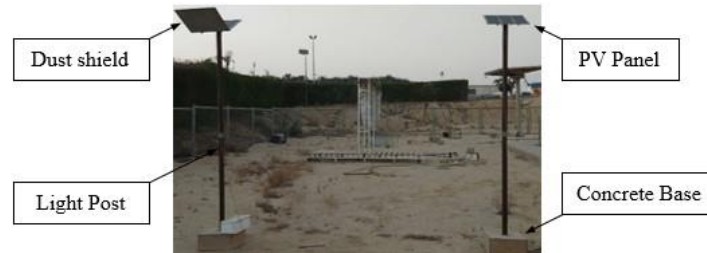
Study on the Anti-fouling Performance to Solar Panels in Egypt

This study evaluated the effectiveness of anti-fouling technologies on solar panels installed on streetlights in Cairo, Egypt. The primary objective of the research was to investigate the seasonal impact of a new anti-fouling system that combines an anti-soiling shield, an anti-static super-hydrophilic coating, and a mechanical vibrator.

- The "shield panel" with the anti-static super-hydrophilic coating maintained an efficiency reduction rate of less than 10% over six weeks.
- The cleaning effect from rainfall was significant; in the fourth week, the normal panel showed only a 13.4% improvement, while the shield panel improved by 39.6%.
- The combined effect of the mechanical vibrator minimized dirt accumulation even in dry conditions.

- Due to the absence of rainfall, the effectiveness of the coating was limited, but efficiency reduction was kept below 10% until the fifth week.
- In environments with minimal rainfall and wind, the effectiveness of the anti-soiling system was shown to weaken.

The anti-static super-hydrophilic coating, when combined with an anti-soiling shield and a mechanical vibrator, has been proven to be an effective anti-soiling technology, particularly in environments where rainfall can be expected. This system enables the maintenance of solar panel efficiency on streetlights and is expected to reduce maintenance costs.
