THERMAL PAINT for outdoor unit

Waterproof auxiliary & rust-proof coating for outdoor unit and its surroundings

What is the thermal coating for outdoor unit and surroundings?

Thermo ECO Shield application system achieves Rust prevention, heat insulation and antifouling shield. As a result, the load on the compressor is reduced leading to **energy savings of 15% or more.** .

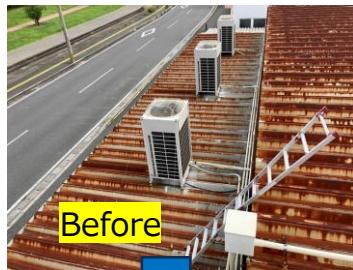
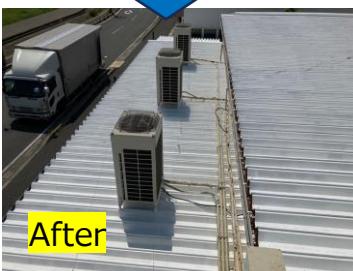
waterproof auxiliary
& rust-proof coating
「Rust Shield」

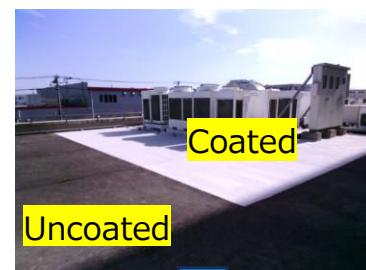
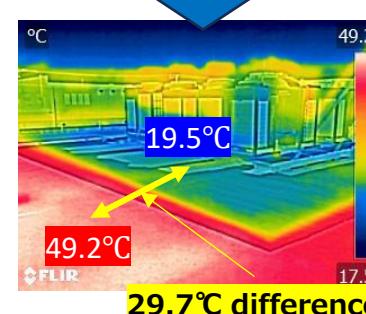
Heat Reflection
& Thermal insulation Paint
「Thermo ECO Shield」

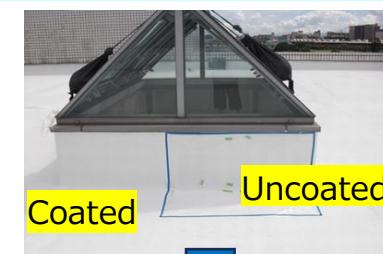
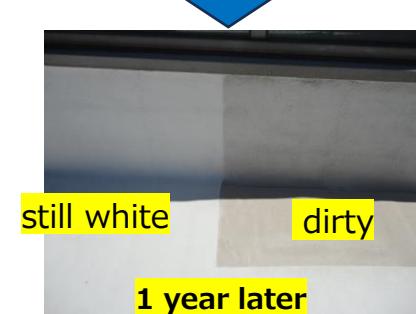
Anti-Static, Super Hydrophilic
Antifouling Coat
& maintaining reflectance
「Super Glass Barrier」

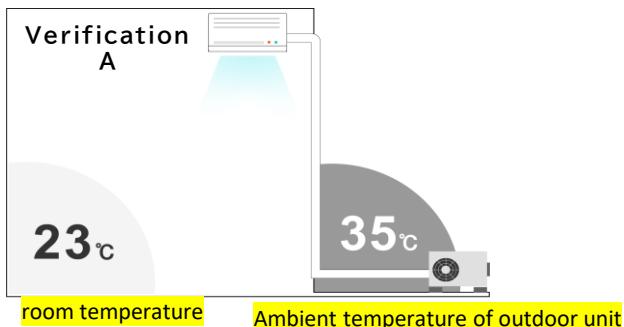
If the ambient temperature of the outdoor unit is 35°C and the indoor temperature is 23°C, the power consumption is 450W.

We conducted an experiment using an air conditioner installed in our Akagi Test Center's experimental house. The indoor set temperatures were set to 23°C and 28°C, while the temperatures around the outdoor unit were set to 35°C and 30°C. We applied a heat load of 2.3 kW and measured the power consumption. The air conditioner used in the experiment had a rated cooling capacity of 2.2 kW and a rated COP of 5.57 (with a rated power consumption of 395 W during rated operation)

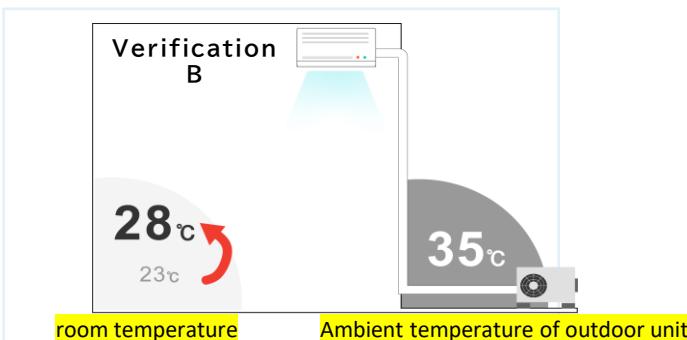
When the room temperature was raised by 5°C, the power consumption decreased by 128W compared to A.

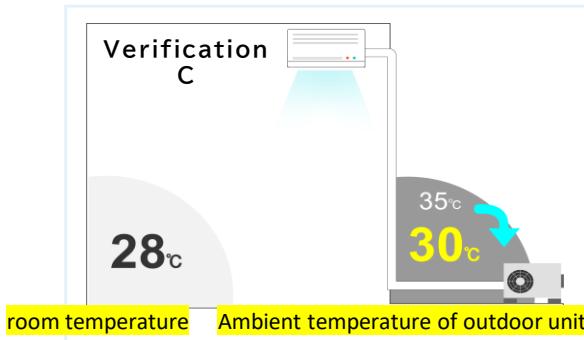
Lowering the ambient temperature of the outdoor unit by 5°C reduced power consumption by 135W compared to B.

Based on the above results, lowering the ambient temperature of the outdoor unit is effective for power saving.

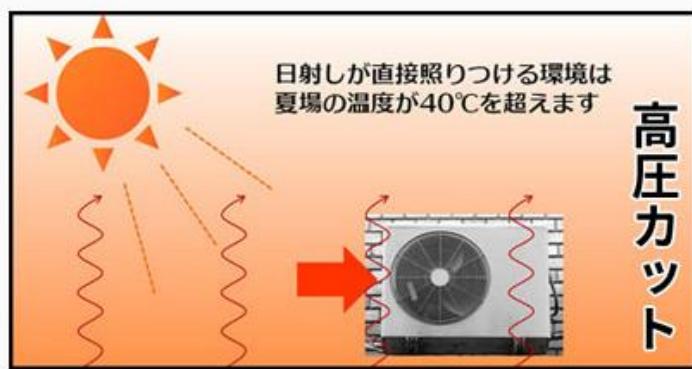
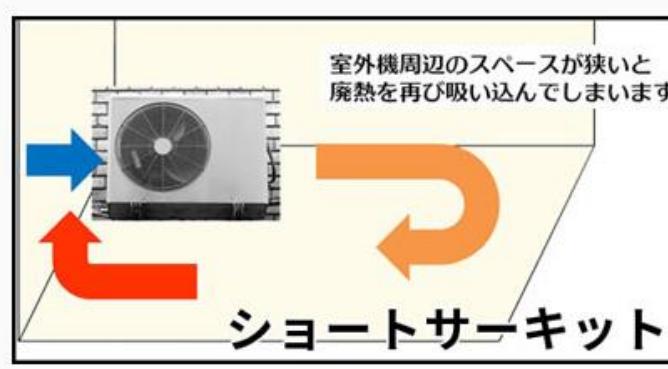
What is high-pressure cutting? Problems with high-pressure cutting

- ・高压カットとは、室外機から室内機(エアコン・冷凍冷蔵ショーケース)へと送られる冷媒に対する圧力が過剰に高まり、**安全のため緊急停止=異常停止を起こすトラブル**を言います。(ショートサーキットも含む)
A high pressure cut is a problem that occurs when the pressure of the refrigerant sent from the outdoor unit to the indoor unit (air conditioner or refrigerated/freezer showcase) becomes excessive, causing an emergency stop for safety reasons (including a short circuit).
- ・室外機及び周辺が高温になりすぎると冷媒を冷やしきれなくなり高压カットが発生します。
- If the outdoor unit and its surroundings become too hot, the refrigerant cannot be cooled sufficiently and a high pressure cut will occur.

The higher voltage cuts are repeated, the more electricity is consumed, which increases the load and shortens the lifespan of the equipment.

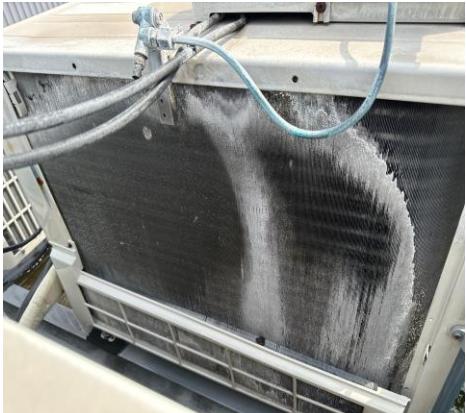
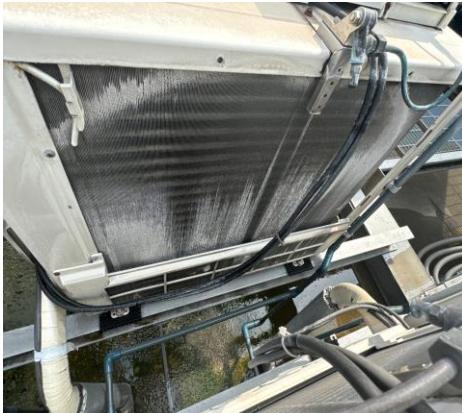
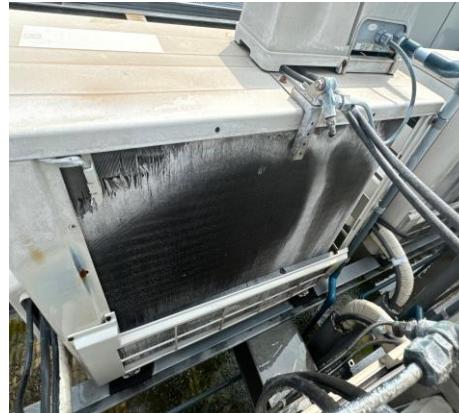
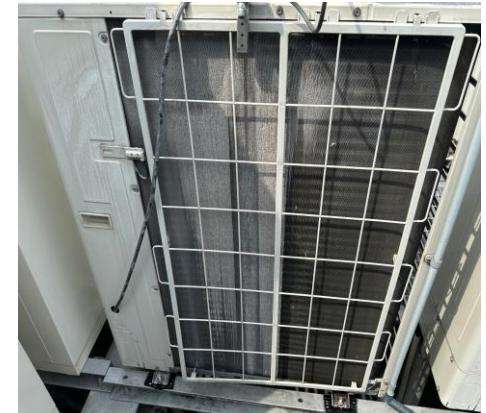
Silica adhesion problem caused by water sprinkling
⇒ Significant deterioration of outdoor unit

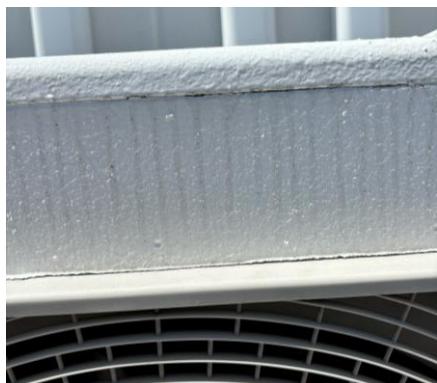
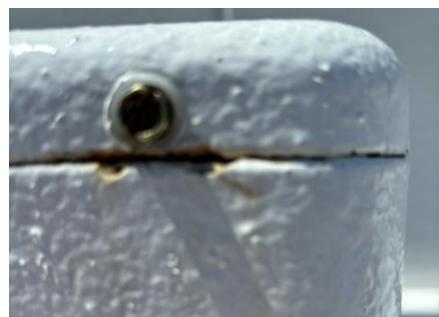
Other companies also apply heat-insulating paint to their outdoor units, but their product degrades faster over time causing rust and dirt accumulation causing the deterioration Of the unit and poor efficiency.

Also, the outdoor unit is hot to the touch so it is not effective.

- Problems with paint performance
- Problems with thin film thickness during application

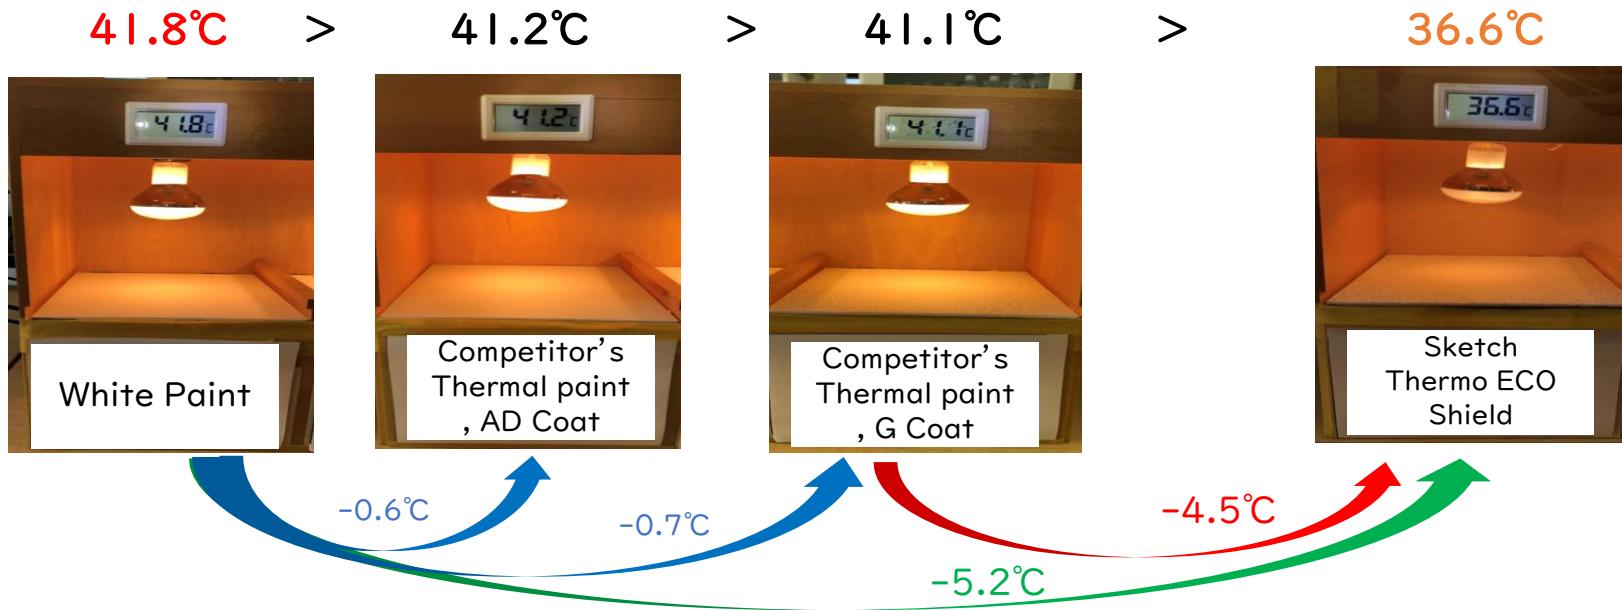
Thermal insulation performance comparison test

Spatial temperature of the sensor installed inside the box

Spatial temperature difference of 5.2°C with white paint,
4.5°C difference with other company's thermal insulation paint

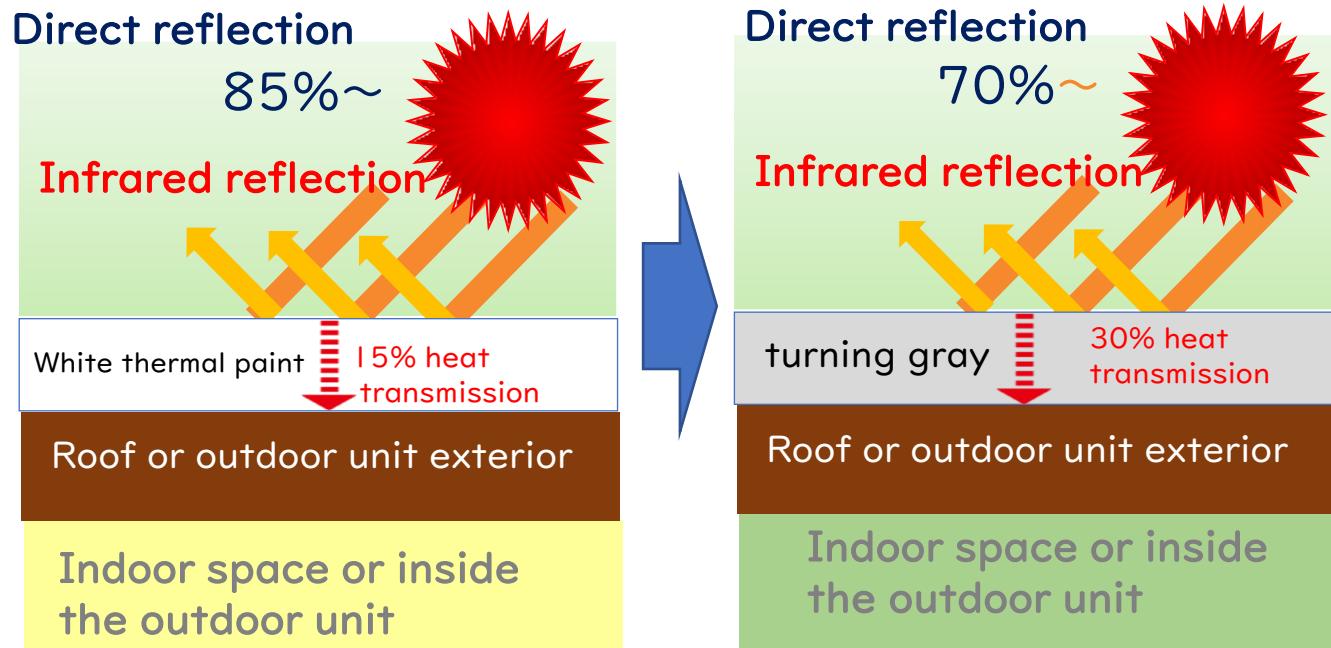
Degradation of white color due to adhesion of dirt

Result: After conducting a test application with another company's heat-reflective paint, our painted surfaces maintained their white color even after 2 months, proving the sustained heat-insulating effect due to the maintenance of infrared reflectance. As a result, our company was chosen, and **we carried out a 2000m² application.**

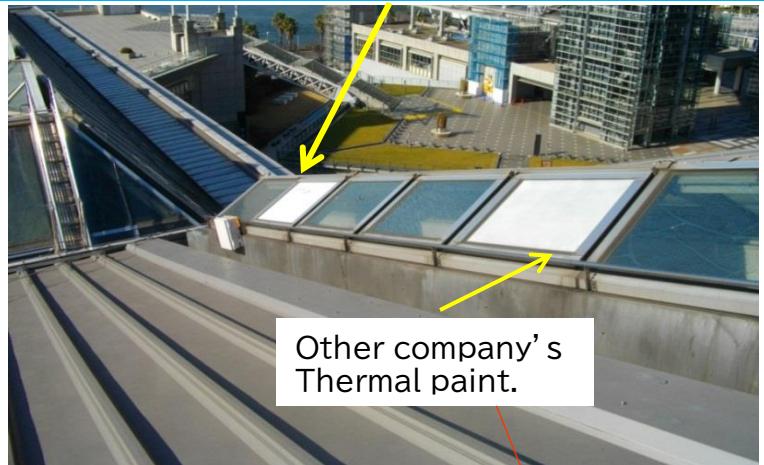
Thermal paint of other companies + Anti-dust nano coat + Super Glass Barrier

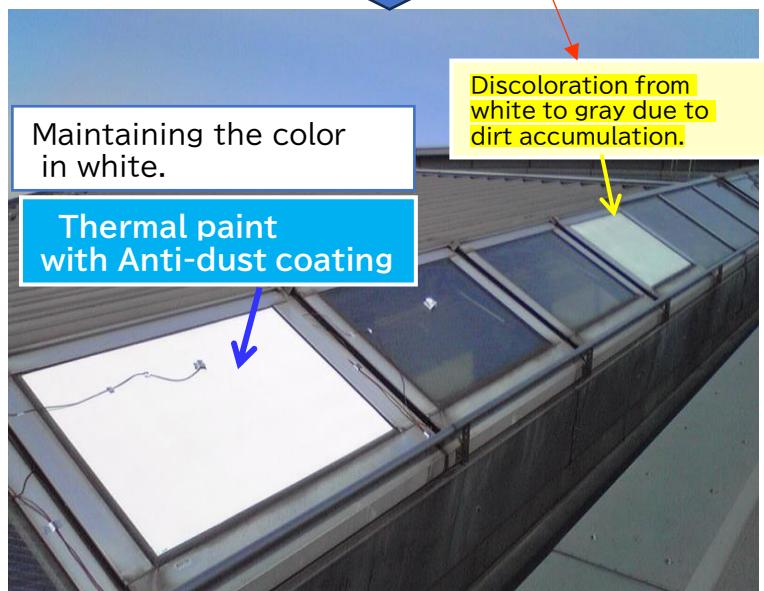
2months later
